Manhole Inspection Summary

Manhole # S11OO1006MH

Insp Date: **11/14/08 2:20 PM**

Location Address: **2925 THORNDALE AVE**

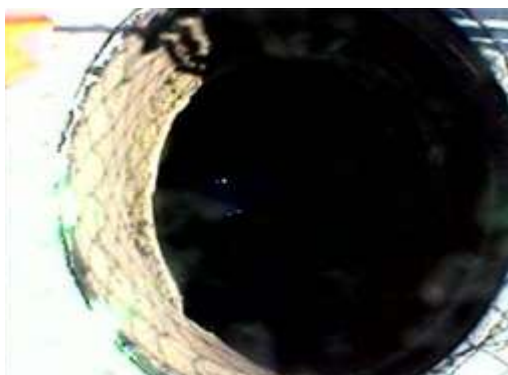
Defect 1

Offset: **2** (in.)

FRAME OFFSET

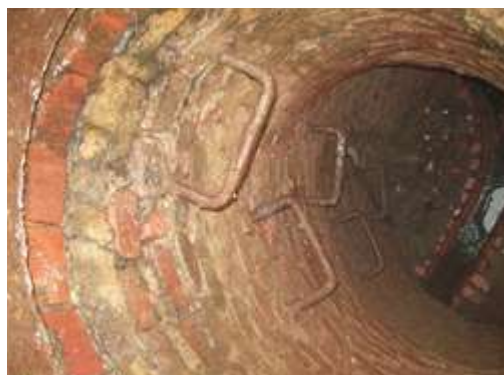
Defect 4

Count: **5** Missing: **0** ☒ **Corroded**

CORRODED STEPS

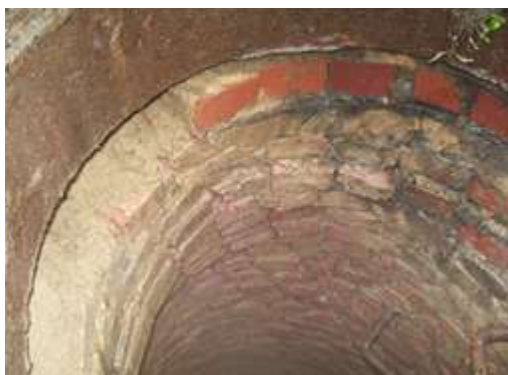
Defect 3

Condition: ☐ Sound ☐ Cracked ☐ Root Intrusion ☒ **Loose Brick** ☒ **Deteriorated**

DETERIORATED CHIMNEY

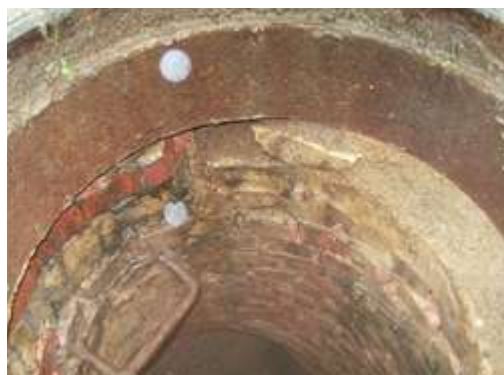
Defect 2

CHIMNEY LOOSE BRICK

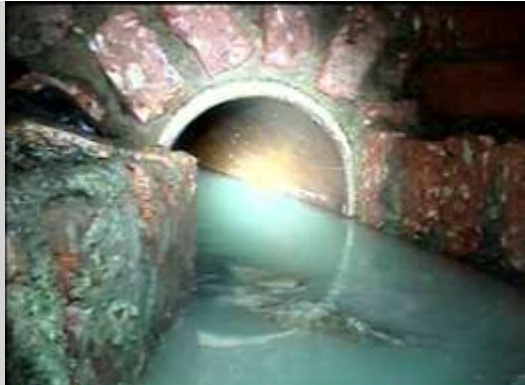
12 O'Clock Outflow

8 in. Circular Gravity Sewer
Pipe Out @ 12 O'Clock

Pipe Material: **Clay** ☐ Pipe Lined

Invert Depth: **9.16** (ft.) Flow Characteristics: **Slow**

Infiltration: **None** Pipe Seal Cond: **Sound**

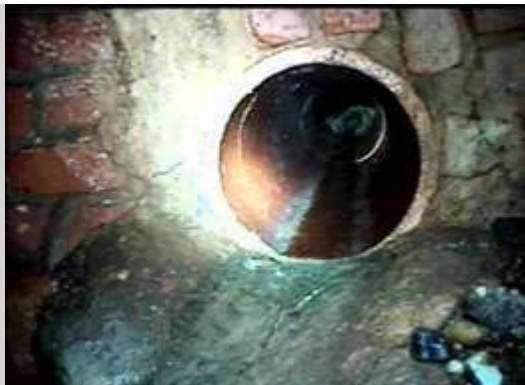
3 O'Clock Inflow

8 in. Circular Gravity Sewer
Pipe In @ 3 O'Clock

Pipe Material: **Clay** ☐ Pipe Lined

Invert Depth: **8.75** (ft.) Flow Characteristics: **None**

Infiltration: **None** Pipe Seal Cond: **Sound**

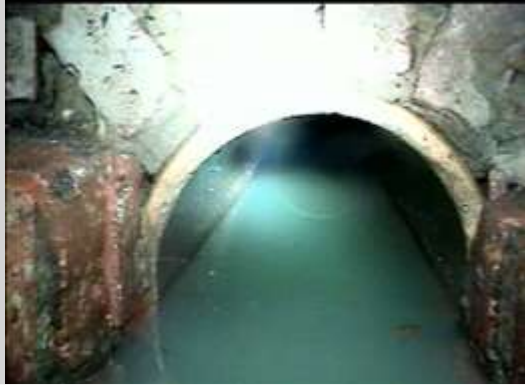
9 O'Clock Inflow

8 in. Circular Gravity Sewer
Pipe In @ 9 O'Clock

Pipe Material: **Clay** ☐ Pipe Lined

Invert Depth: **9.20** (ft.) Flow Characteristics: **Slow**

Infiltration: **None** Pipe Seal Cond: **Sound**
